## C7 SERVICE ADVICE

The C7 valve is manufactured from quality materials and has been engineered to ensure a long life in arduous Marine environments. In the unlikely event that you experience problems with this product you may find the following notes helpful.

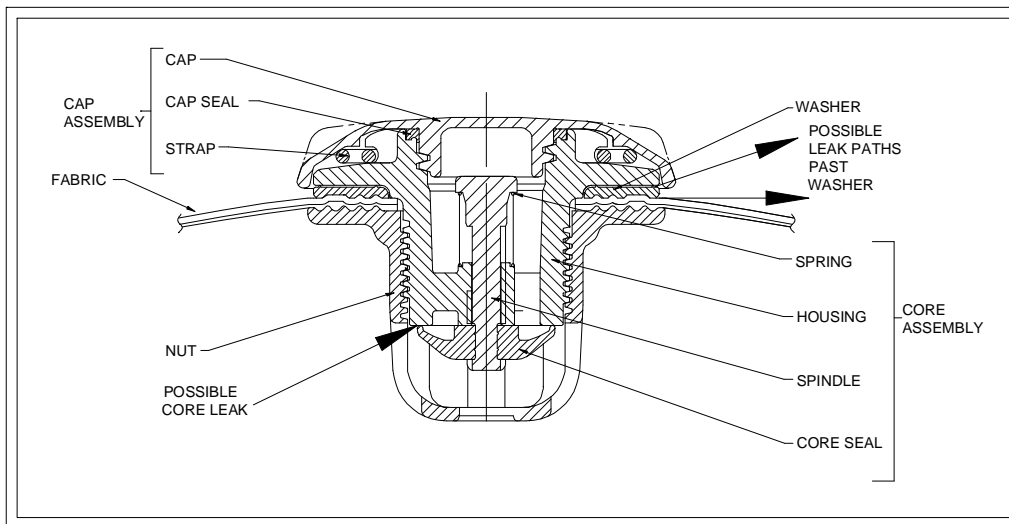
First identify where the leak is coming from- see diagram below.

#### (a) Leakage from the Core Assembly.

This problem can be temporarily overcome by fitting the cap, as this is a secondary seal. To permanently fix the problem, carry out the following operations: -

- (i) With the buoyancy tube deflated and the valve in the closed position, remove the Cap, then fill the valve with some warm soapy water. Open the valve by pushing the Spindle down and turning anti-clockwise. Allow the water to drain through. Rinse through with plain water. Re-check the valve for air tightness.

- (ii) If leakage persists, use service tool C16605 with the buoyancy deflated and unscrew the core of the valve by turning it anti-clockwise. Remove the core, noting the position of the washer and its colour. If it is grey we would recommend that you discard it and fit the improved black version. It is not necessary to fit the thin sealing gasket with this washer. Apart from the colour, the improved washer can also be identified by the two thin circular ridges on one side and four larger ridges on the reverse. Check the Rubber seal on the valve core for dirt or damage. Check that the sealing face on the plastic core is clean and undamaged. If the seal or core are damaged the core assembly must be replaced.

- (iii) Refit the valve ensuring that the washer is replaced in the correct orientation (see picture below for orientation) and tighten as tightly as you can using hand pressure on the tool. Inflate the buoyancy tube and check for air tightness. We recommend that after around 24 hours the valve should be retightened to ensure it has fully seated. If leakage persists contact your local repair shop.

### (b) Leakage from the edge of the Valve.

- (i) Using tool C16605, ensure that the valve is as tight as possible with hand pressure only.
- (ii) If the leak persists, unscrew the valve core and remove. If the washer is grey, or there is a thin sealing gasket fitted, discard these and fit the improved washer, which is black and does not require a gasket. The two thin ridges on one side and 4 larger ridges on the other can also identify the improved washer. Check the valve core for any damage in the area that clamps against the washer. If this area is damaged, replace the core assembly. Make sure that there are no tears or areas of damaged fabric where the valve clamps, if there are the repair will have to be carried out by a repair shop.

- (iii) Refit the valve, ensuring that the washer is replaced in the correct orientation and tighten as tightly as you can using hand pressure on the tool. Inflate the buoyancy tube and check for air tightness. We recommend that the valve is re-tightened after about 24 hours to ensure it has fully seated. If the leakage persists, contact your local repair shop.

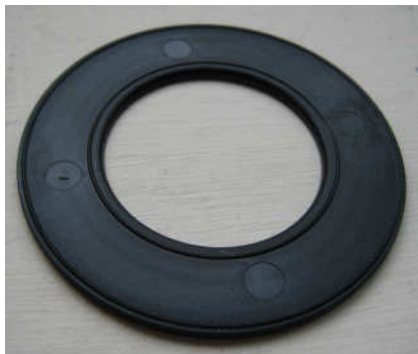
### Washer Orientation

2 ridges:  
This side  
facing up

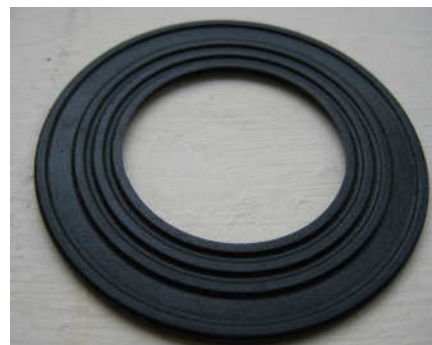
4 ridges:  
This side against  
the boat fabric

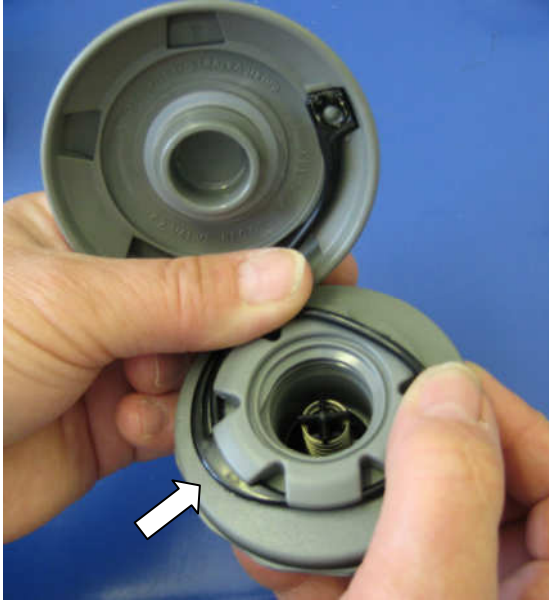
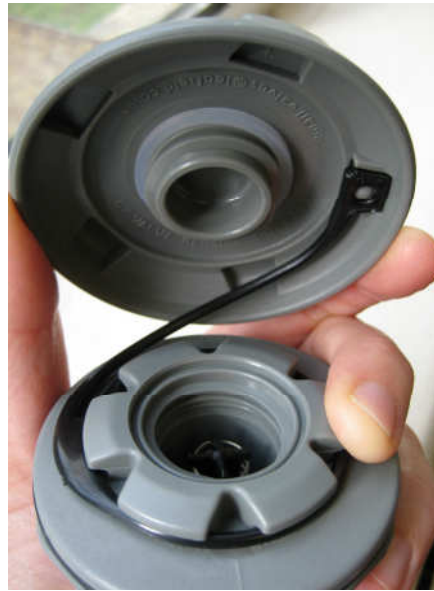
- (i) If the cap has been broken or the strap damaged, a new Cap/strap assembly can be obtained from your spares supplier. The loop securing the cap to the valve can be cut using a knife- being careful not to damage you or the raft fabric. The new loop can then be pushed over the retaining features (start with the thickest part of the strap) and will clip into place securing the cap firmly. Make sure the strap is the right way up before fitting, so there are no twists in the strap when you screw the cap on.
